92 Washer solvent level warning is on

92 19 23 2038151/10 November 12, 2019. Supersedes Technical Service Bulletin Group 92 number 19-17 dated February 7, 2019 for reasons listed below.

Model(s)	Year	VIN Range	Vehicle-Specific Equipment
All	2012 - 2021	All	Not Applicable

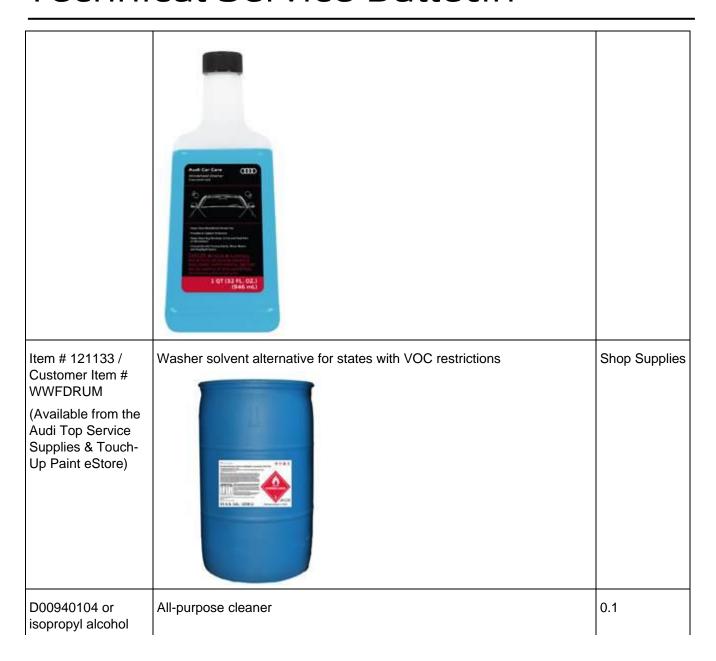
Figure 1. D 009 401 04 all-purpose cleaner.
